Property Inspection Report

1042 Nelson Court, Anytown

06/02/2013 Report #9003970

Inspected by: Glenn Stewart, The House Whisperer 925-243-1861

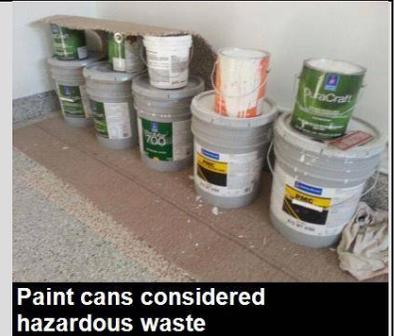
There appears to be stored hazardous waste on the property (paint cans, car battery, solvent, oil, etc). Most local governments have hazardous waste management programs for disposal of hazardous waste items. We recommend removal of hazardous waste prior to the close of the contingency period.

Paint cans considered hazardous waste

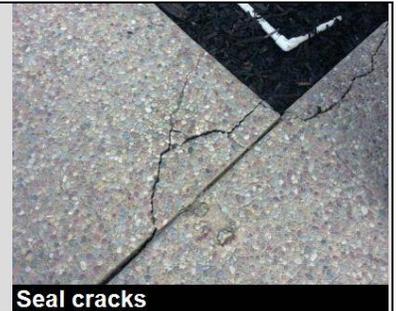
2.2 CONDITION:

Small to moderate cracks were noted in the left side walkway. We recommend sealing all cracks to minimize water intrusion and possible settlement/deterioration. The front entry walkway was in serviceable condition at the time of our inspection.

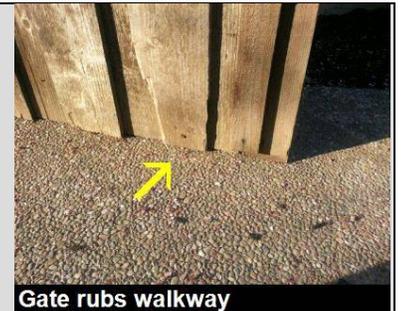
2.14 GATE CONDITION:

The right side gate was difficult to open and close, rubs the walkway, and/or did not latch properly. We recommend adjustment and/or repair to restore proper function.

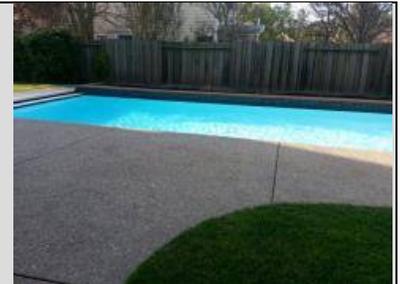
No safety barrier was installed around the pool, which may not meet the local building jurisdiction requirements for swimming pool installations. This is a potential drowning hazard for small children. We recommend the installation of a proper pool barrier system. Contact a qualified swimming pool specialist.

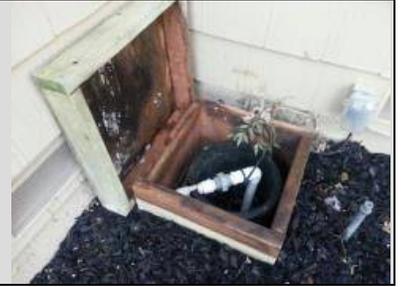
**2.19 SUMP PUMP
CONDITION:**

A sump pump has been installed at the right side to remove accumulated water from a sump (shallow well). The pump was not observed under actual working conditions. Ask the seller to comment on its operation or have a licensed plumber review.

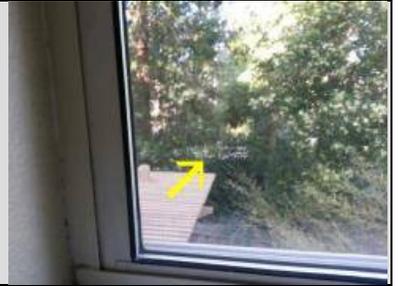
3.7 CONDITION:

One or more window screens around the house were damaged, torn and/or had holes in them... master bathroom toilet room. We recommend repair or replacement of the damaged screens.

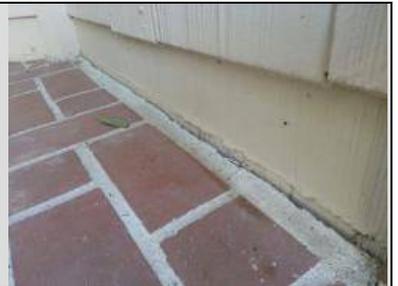
3.9 CONDITION:

Settlement was noted at the rear left steps and has created a gap between the house wall and the steps, an entry point for water intrusion. We recommend sealing the gap as a minimum and monitoring the steps for further movement.

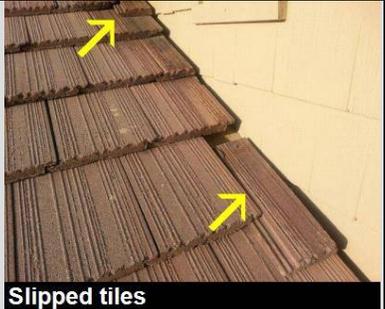
<p>One or more tiles have slipped out of place at the front gable roof. We recommend loose tiles be secured back in place. We recommend further review by a licensed roofing contractor.</p> <p>One or more missing, damaged or cracked roof tiles were noted throughout the roof field. There is the potential for moisture intrusion. We recommend further review by a licensed roofing contractor.</p>

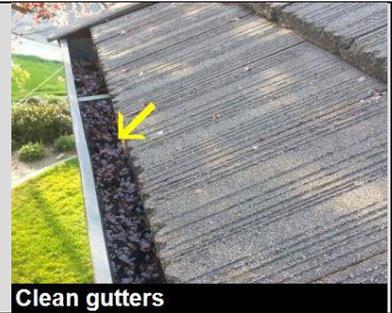
Debris was noted in the right side gutters. Excessive debris can cause the gutters to deteriorate and clog downspouts. We recommend cleaning and consideration given to installing gutter screens.

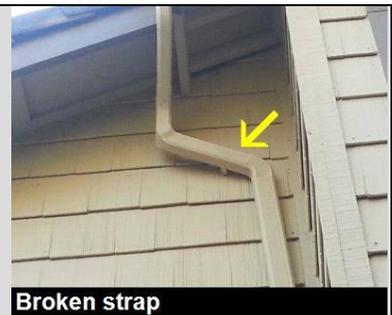
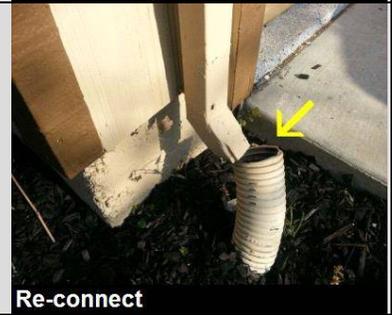
4.12 DOWNSPOUT CONDITION:

There were one or more loose or missing gutter downspout straps around the building. In many cases the water weight causes the downspout to slip away from the gutter. We recommend repair. One or more downspouts are disconnected from the sub-surface drainage collection system. Correction recommend to ensure proper site drainage.

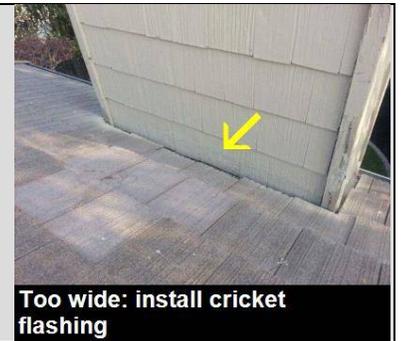
The exterior chimney appears to be in serviceable condition. The base of the right side and left side chimneys is wider than 30 inches and is conducive to trapping debris and water behind the chimney and/or chase siding. Upgrading, by installing a cricket flashing to divert water behind the chimney is recommended by a licensed roofing contractor.

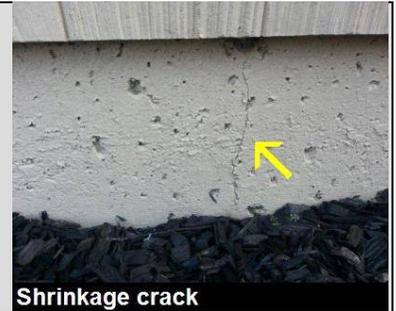
Shrinkage and/or minor settlement cracks were noted in one or more sections of the concrete stemwall foundation. The observed surface cracks ran randomly on the concrete foundation stemwall. This is a relatively common condition and is the result of curing concrete (shrinkage cracks) due to conditions at the time of construction and/or the curing of the concrete foundation. No adverse conditions were noted and no action is indicated.

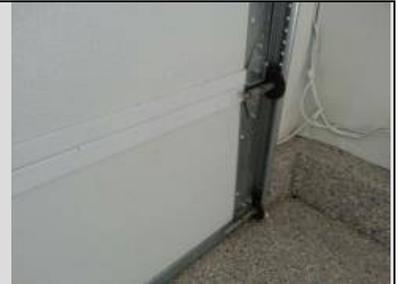
The garage door opener(s) lacked the required infrared light beam for reversing a garage door. All garage door openers manufactured after 1993 are required to have an external reversing mechanism (an infrared light beam) to protect children and pets from a closing garage door. As a safety upgrade, we recommend that consideration be given to installing an infrared beam on all garage doors with an opener.

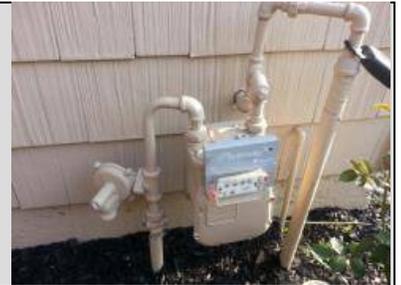
The natural gas meter was located on left side of the garage.

There was no gas valve shutoff wrench attached to the gas meter. We recommend attaching a wrench to the meter so the gas can be manually shut off in an emergency.

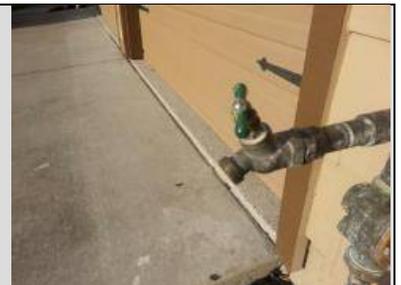
Some of the water faucets (hose bibs) are protected by anti-siphon valves, while others are not. These protect the potable water supply with a vacuum breaker fitting in the event there's a break in the main water supply line. Although these may not have been required at the time the home was built, we recommend installing anti-siphons on all of the faucets.

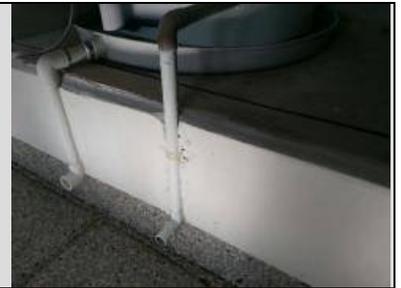
8.16 RELIEF VALVE:

The temperature-pressure relief valve drain line terminates next to the water heater or into a water containment pan. This configuration does not meet current requirements of terminating at the exterior or to an approved receptor. This is a potential safety hazard as a person could be scalded, if the temperature pressure relief valve were to open. As a safety upgrade, we further review by a qualified water heater specialist.

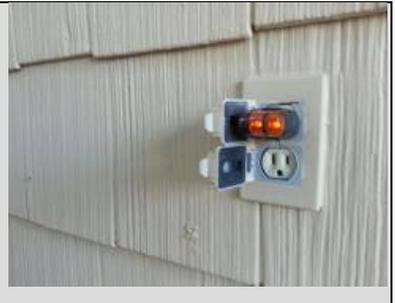
There did not appear to be GFCI outlets (electrical wall outlets with a built-in circuit breaker with test and reset buttons) or a labeled GFCI outlet installed at the exterior walls per today's requirements. This is a potential electrical safety hazard. Although GFCI (ground fault circuit interrupters) outlets may not have been a requirement when this house was built, we recommend upgrading for electrical safety at the exterior of the house. Contact a licensed electrician.

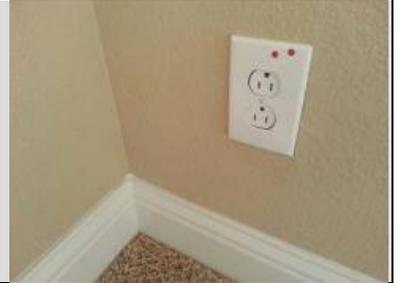
One or more electrical wall outlets were found to be loose in the front living room, master bathroom and front entry hall wall... marked with 2 red dots). This is a potential electrical safety concern. Contact a licensed electrician.

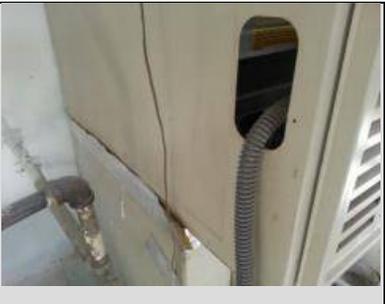
A flexible gas connector (pipe) was installed through the furnace sheetmetal housing. This makes the flexible gas connector susceptible to damage in the event of seismic activity or furnace blower vibration; when the flexible gas pipe is against the thin sheetmetal edge. As a safety precaution, we recommend centering the flexible gas connector in the sheetmetal opening or taping the edge of the sheetmetal will minimize possible damage to the flexible gas connector during a seismic event.

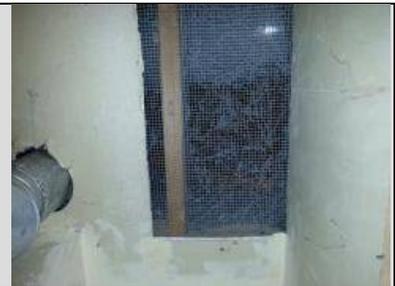
The upper ceiling combustion air vent in the heating furnace closet was screened per previous building requirements; but is subject to blockage by dust, debris and loose insulation. As a safety upgrade, we recommend having the screen removed to meet today's requirements. Contact a licensed HVAC contractor.

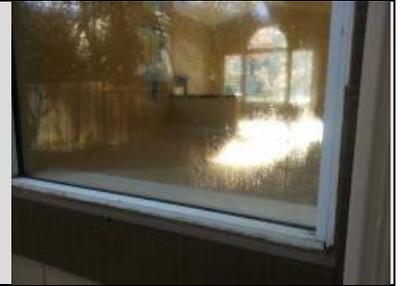
One or more dual pane windows in the dining area appear to have failed seals. A failed window glass seal is where inert gas leaks out between panes of glass usually resulting in a fogginess and /or streaking of the window. There is no repair for this condition and is considered a cosmetic condition. Contact a qualified door specialist for replacement.

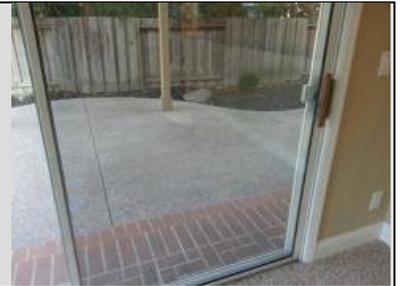
11.5 CONDITION:

The family room sliding glass door was missing. We recommend installing a screen door for ventilation and to keep out bugs and insects.

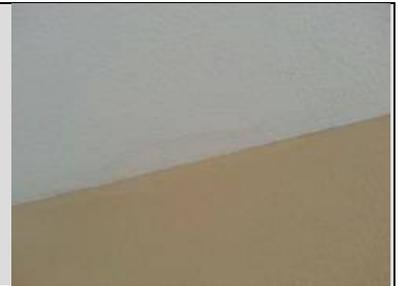
Water stains were noted on the master bedroom left side wall-ceiling and in the front left bedroom closet ceiling. The source of water intrusion should be identified and repaired. We recommend further review by a licensed roofing contractor and review of a current structural pest report.

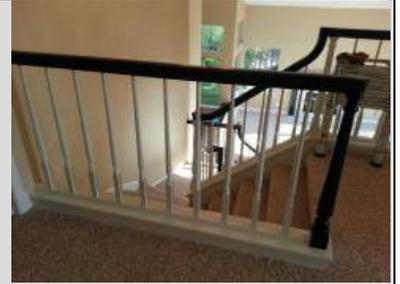
The interior stairs and handrails appeared to be in serviceable condition. The spacing between the vertical stairs railing and/or guard railing is greater than 4 inches. This was acceptable practice at the time the house was built; but doesn't meet current requirements. This may be a safety concern for small children. We recommend upgrading the railings for enhanced safety per current requirements building requirements or installing a temporary barrier. Temporary barriers: "kid shield banister guard" are available at Amazon.com, Babies R Us.com, SafeHomeProducts.com, TotsSafe.com

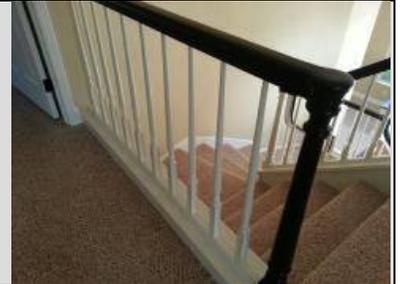
11.23 CONDITION S1

The interior stairs hand railing was loose (moves back and forth). This is a stair safety concern. We highly recommend further review by a licensed contractor prior to the close of the contingency period.
